Indiana University of Pennsylvania
Academy of Culinary Arts
Master Plan

February 1, 2018 (Updated February 24, 2022)

The purpose of this report is to provide a written description of the condition of the existing facilities at Indiana University of Pennsylvania's Academy of Culinary Arts in Punxsutawney, Pennsylvania.

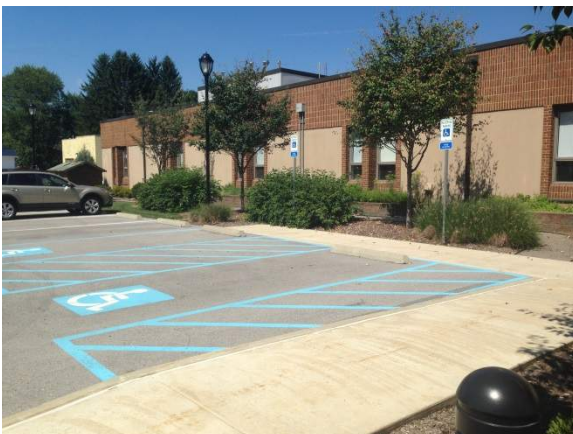
A more detailed parking study will be required, as part of the ongoing master planning efforts. However, there appears to be inadequate bicycle racks on site. The vehicle parking is in very good condition, with ADA van and vehicle parking available. Further study would be needed to determine the required number of dedicated handicapped parking spots required by code. Currently there is no covered drop-off area for visitor's vehicles and/or shuttle buses.

View of ADA Parking on South Side of Building

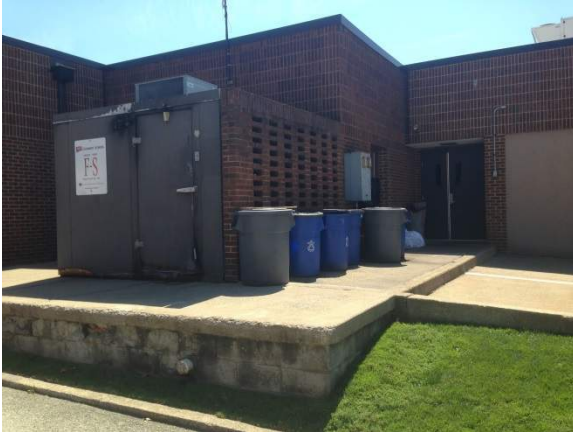
At the rear of the building, there is a small concrete loading area; most of its space is occupied by a walk-in cooler and a series of 55-gallon recycling bins and garbage cans. Where the trucks back in, the curb is approximately 6" to 8" high, rather than a full height dock. The asphalt is striped for 2 truck parking spaces and 1 dumpster. The existing concrete steps and curbs show some damage. Currently there is no dock lift, bumpers, or bollards in this area. The Faculty and Facilities Staff noted that the loading dock is difficult to access, and visibility is limited. Delivery trucks often run into the curbs, damaging them.

View of Loading Area and Walk-In Cooler from North

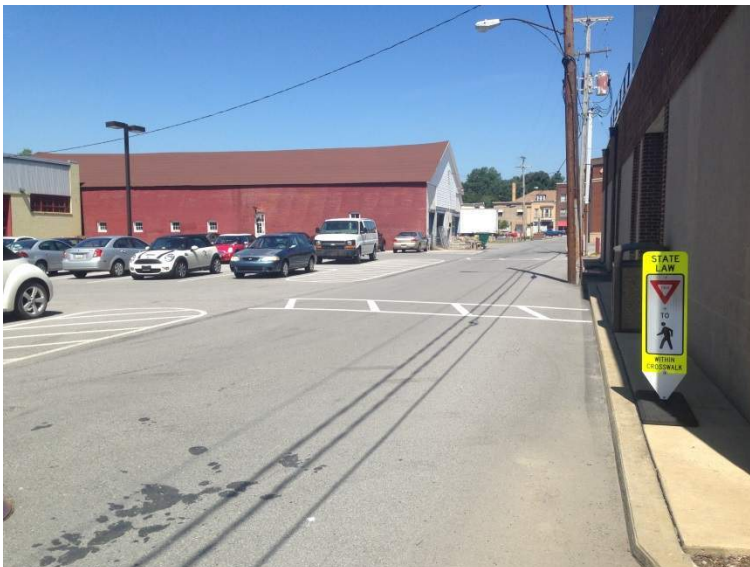
Pedestrian Safety at the rear of the building is of concern. To reach the parking lot, students/staff must cross a tight alleyway, which is often occupied by vehicles and delivery trucks, and which has limited visibility. However, the front and side of the building appear to have adequate sidewalk circulation. The Faculty expressed a concern about inadequate site lighting and security systems.

View of Parking and Pedestrian Crossing on the Rear (West Side) of Building
(Main Building is on the Right)

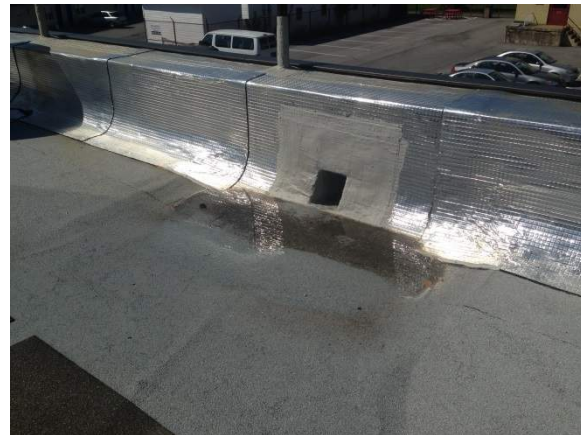
1. Roof:
The roof is in very good condition, having been replaced 2 to 3 years prior to the time of the survey. Historically, high-albedo (white) roofing systems, like this one, have proved to be effective in reflecting sunlight, minimizing the absorption of summer heat, and reducing the air-conditioning requirements of a building, as compared to dark-colored roofing systems. Some minor ponding near one of the roof scuppers was observed at the time of the walk-through. This may have been the result of a large rainstorm the day/night before. The scuppers should be cleared of any debris, and the roof slope should be adjusted, as needed, to ensure proper drainage and to preclude damage to the interior of the building.

Water Pooling near Existing Roof Scupper

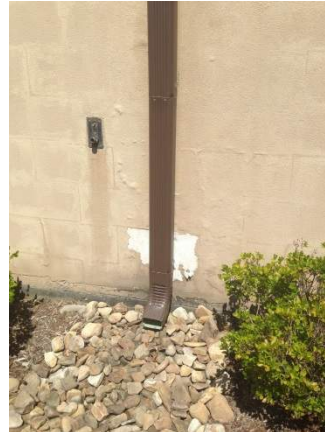
Damaged Stucco at Downspout

The stucco veneer is in fair condition. Some portions of the existing stucco, particularly behind the downspouts, appear to have water damage and are peeling. Further investigation should be made to determine whether there is any water penetration in these areas. The problem may be exacerbated by the winter freeze-thaw cycle.

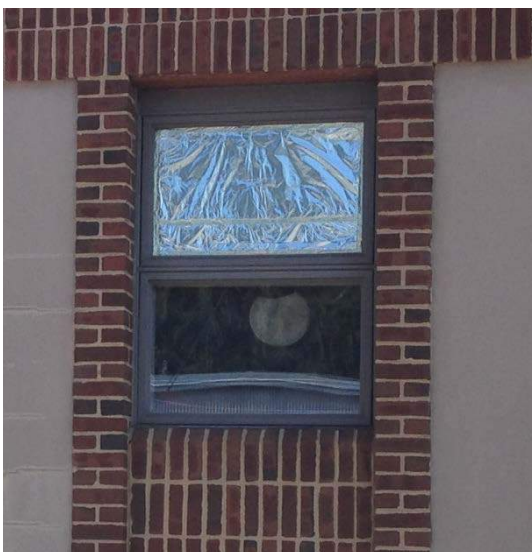
The exterior windows and doors are insulated aluminum storefront units. The windows are in fair to poor condition. The doors appeared to be in fair to good condition. Some doors did not have ADA-compliant hardware. The Facilities Staff noted that the windows are outdated, and replacement parts for them are difficult to find. In many of the teaching kitchens, the upper pane of glass was covered with aluminum cooking foil, to block glare coming into the rooms.

Foil on Kitchen Windows, View from Exterior

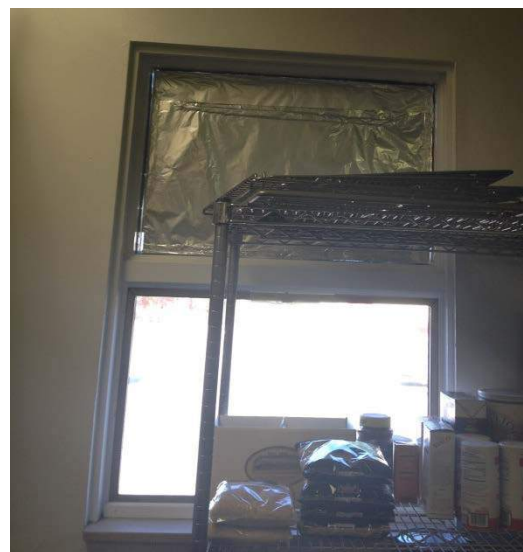
Foil on Kitchen Windows, View from Interior

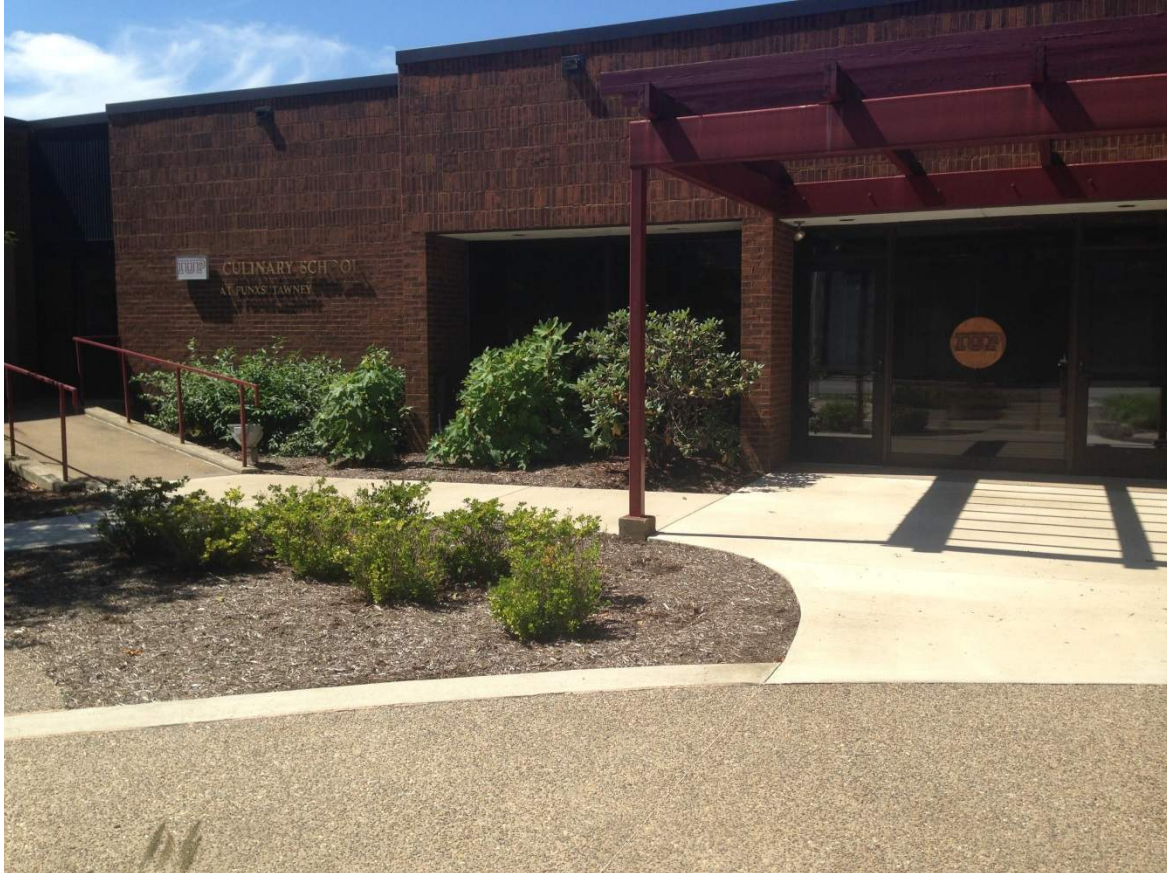
The current layout of the front entry doors is confusing. Visually, there is just as much, if not more, emphasis on the side entry than there is on the main entry vestibule. While the main entry has a canopy over it, the door is otherwise not well-marked. The side entry has a large ramp leading up to it, and the main building sign is next to this door, implying that it is the main public entrance instead of a student/staff entrance.

View of East Side of Building (Staff/Student Entrance is on Left at top of Ramp; Visitor Entrance is on Right below Canopy)

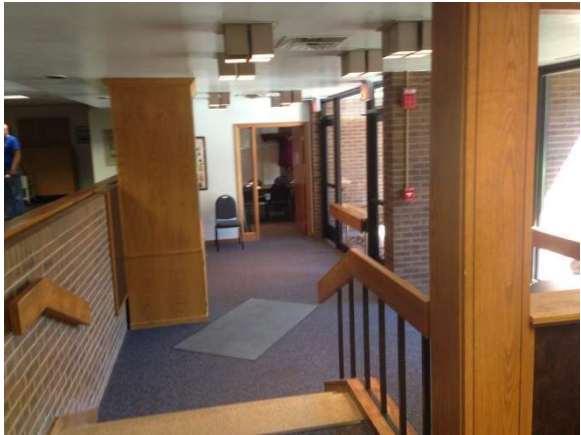
View of Main Lobby

The lobby steps do not have ADA-accessible railings. The lobby and dining rooms have a confusing layout. There is a limited number of display areas for student work, faculty work, awards, admissions materials and student life information. The low ceiling heights and limited natural lighting throughout, particularly in the dining rooms, make them feel cave-like and uninviting. The interior finishes, exposed brick, and lighting are dated in appearance. In general, the area feels more like an office building than a culinary school. There is no student lounge or common area.

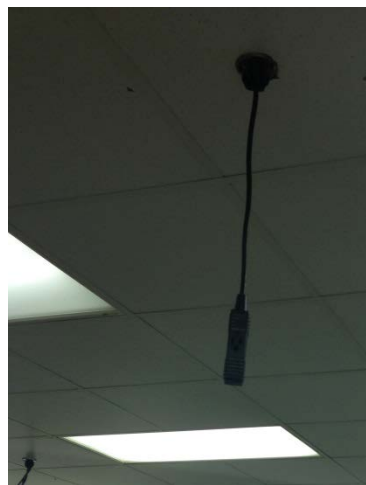
Detail of Power Strip Hung from Kitchen Ceiling

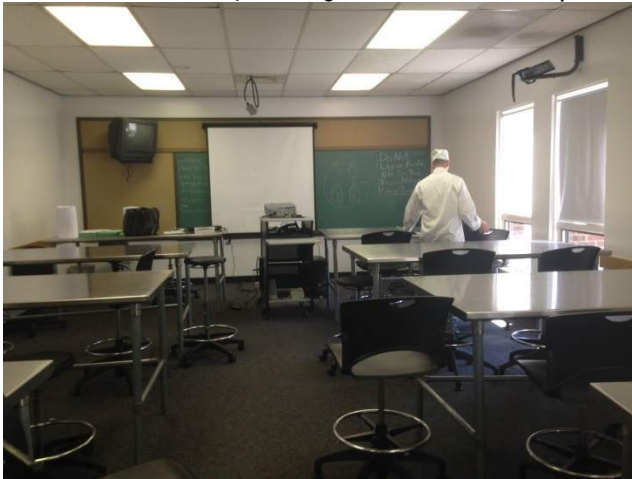
View of Lecture Room

The Lecture Room has conventional acoustical ceiling tile, which is in poor condition. Many of the tiles are discolored or damaged and should be replaced. The ceiling height is lower than in the instructional kitchens, which gives it a more cramped feeling.

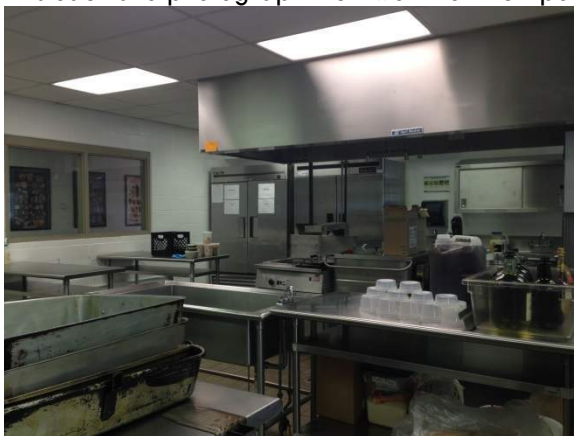
View of Main Hot Preparation Kitchen

The instructional kitchens are cramped and seem undersized. The acoustics are poor in most areas, due to the loudness of the mechanical equipment, even before the cooking hoods are turned on. The layout makes it difficult for students to see the instructor. The exterior windows are small, and access to natural light is limited. The upper panels of the exterior windows have been covered with aluminum cooking foil, in an effort to cut some of the glare. There is inadequate space for the students to photograph their work for their portfolios. Storage is also limited.

The Facility Staff and Faculty noted that, during the summer months, the kitchens can get dangerously warm. Chef Wutsch noted a recent August day when the air temperature in the center kitchen reach 118°F, and a student passed out. He also noted that extreme heat could set off the Ansul systems in the hoods.

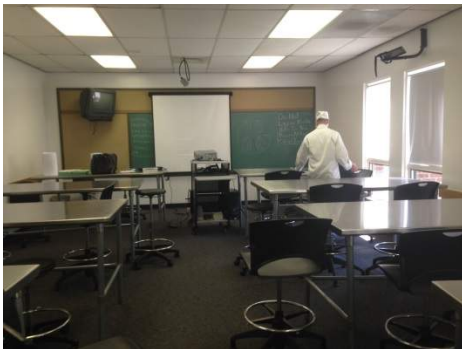
View of Lecture Room

The audio-visual equipment in the Lecture Room is outdated, and there does not appear to be sufficient audio-visual equipment in any of the kitchens. There does not appear to be sufficient lighting in the Lecture Room.

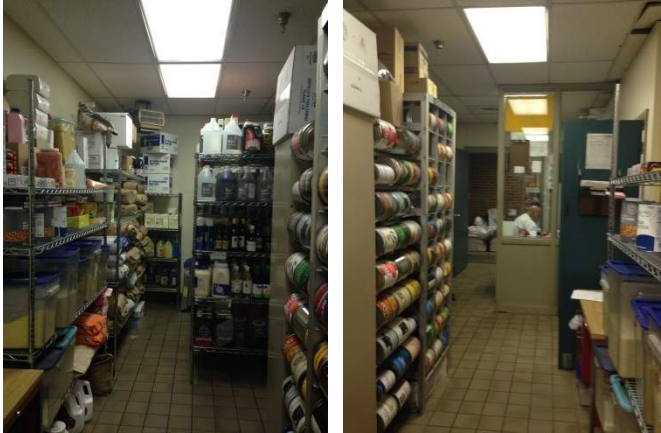
Main Storage Room, Facing West Main Storage Room, Facing East

The main food storage room at the Issuing Kitchen near the loading dock has a conventional acoustic tile ceiling that is in fair to poor condition. Since it is technically not a food prep area, a scrubbable ceiling is not required; however, it is considered good practice. Notwithstanding, some of the existing ceiling tiles are stained or damaged and should be replaced.

The Facility Staff noted that there has been a humidity problem in the main food storage area. It was also noted that this storage room has sprinklers, unlike most of the building. The amount of storage in the building, in general, is insufficient. Some kitchen equipment and supplies storage overflows into the Dining Room.

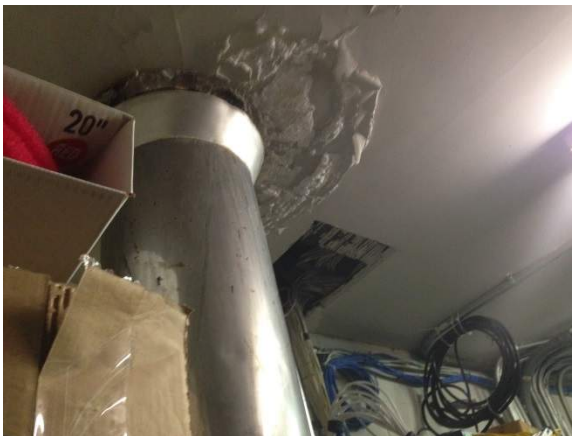
The ceiling in the mechanical/electrical room near the loading dock has a significant amount of moisture damage and should be replaced.

Ceiling Damage, Mechanical/Electrical Room

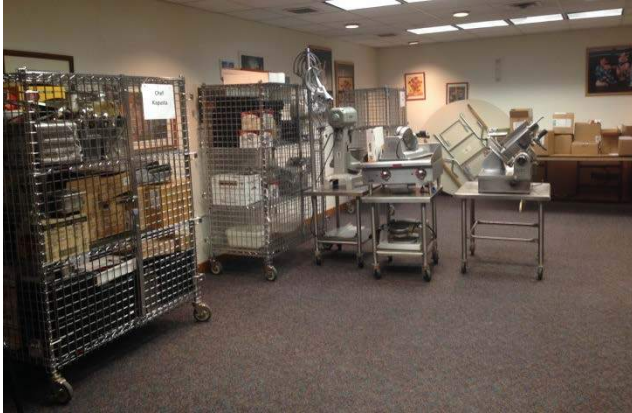
Overflow Storage in Dining Room

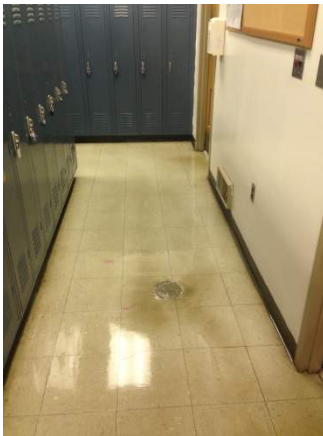
The locker room has VCT flooring that is in fair condition; the tiles closest to the floor drain are stained. The restrooms have ceramic tile flooring which is in fair condition. The grout is stained.

Locker Room Floor Drain

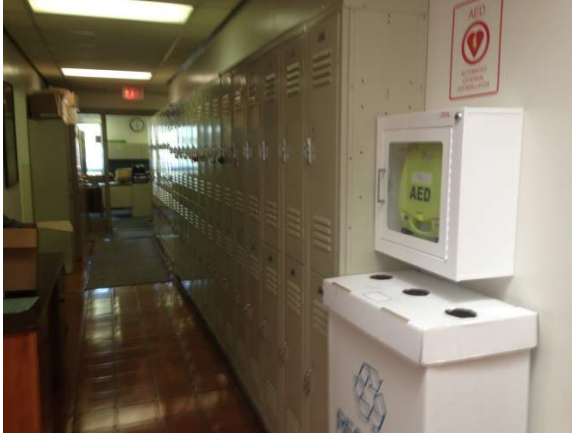
Currently the locker room is open to the hallway. Lockers were also added in the staff corridor as the number of students increased, which causes a bottleneck when the halls are crowded.

Hallway Lockers
