Indiana University of Pennsylvania
Academy of Culinary Arts
Master Plan

February 1, 2018 (Updated February 24, 2022)

The purpose of this report is to provide a written description of the condition of the existing facilities at Indiana University of Pennsylvania's Academy of Culinary Arts in Punxsutawney, Pennsylvania.

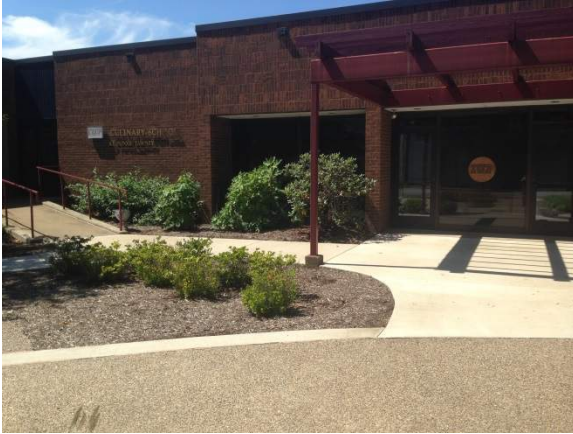
The building holds a prominent location, at the intersection of South Gilpin Street and Route 119. However, the directional signage on-site is limited, and the building appears to be a conventional office building, rather than a culinary school, which confuses some visitors. Façade is dark with dark tinted glazing which makes the facility seem uninviting and does not allow for natural light to enter the building.

View of Main Entrance (East Side of Building)

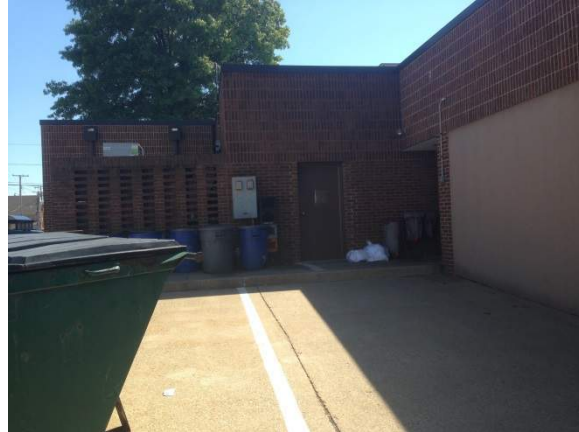
At the rear of the building, there is a small concrete loading area; most of its space is occupied by a walk-in cooler and a series of 55-gallon recycling bins and garbage cans. Where the trucks back in, the curb is approximately 6" to 8" high, rather than a full height dock. The asphalt is striped for 2 truck parking spaces and 1 dumpster. The existing concrete steps and curbs show some damage. Currently there is no dock lift, bumpers, or bollards in this area. The Faculty and Facilities Staff noted that the loading dock is difficult to access, and visibility is limited. Delivery trucks often run into the curbs, damaging them.

View of Loading Area from West

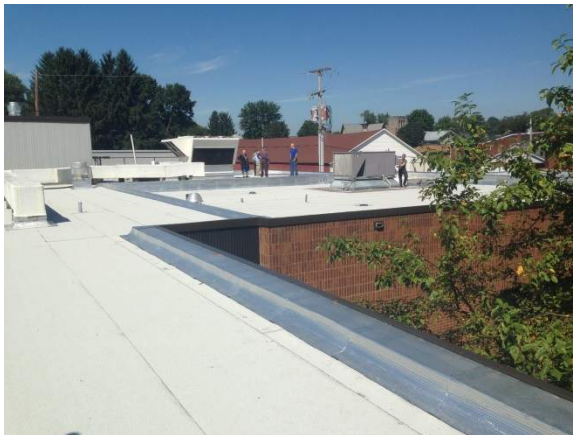
1. Roof:
The roof is in very good condition, having been replaced 2 to 3 years prior to the time of the survey. Historically, high-albedo (white) roofing systems, like this one, have proved to be effective in reflecting sunlight, minimizing the absorption of summer heat, and reducing the air-conditioning requirements of a building, as compared to dark-colored roofing systems. Some minor ponding near one of the roof scuppers was observed at the time of the walk-through. This may have been the result of a large rainstorm the day/night before. The scuppers should be cleared of any debris, and the roof slope should be adjusted, as needed, to ensure proper drainage and to preclude damage to the interior of the building.

View of Roof, Facing Northwest

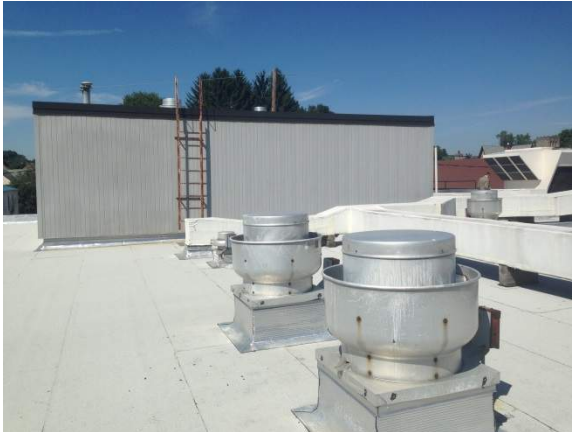
Mechanical Penthouse

The majority of the existing building's construction is face brick with concrete masonry unit (CMU) backup, with stucco veneer on some parts of the first story. Based on the existing drawings, there is no insulation or air space between the layers of masonry. The exterior walls have limited insulation value. The mechanical penthouse façade is an insulated metal panel system. The brick, CMU, and metal panel all appeared to be in good condition.

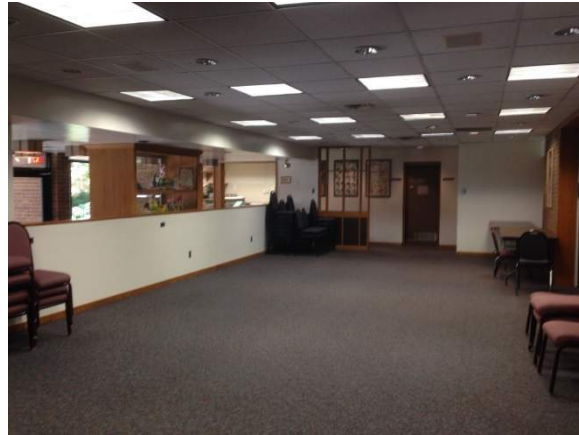
View of Main Dining Room

The dining rooms appear to be underutilized during the day. However, the Faculty noted that they get crowded during the Summer Buffets (80 people or more) and when admissions tours come through the building. The retail counter near the front lobby is underutilized. The refrigerated display case is no longer actively used and takes up a lot of floor space.

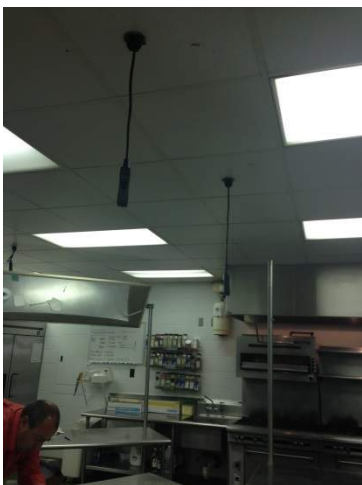
1. Ceilings: The instructional kitchens all have kitchen-grade, scrubbable ceiling tiles, as required by Food Safety regulations. They have yellowed in most areas and appear dated. In each kitchen, the Facilities Staff added power strips, hung from the ceiling, to provide power to the movable tables. In general, the kitchen ceilings appear to be in fair to good condition. The ceilings are fairly high, which is appropriate for teaching kitchens.

View of Typical Instructional Kitchen

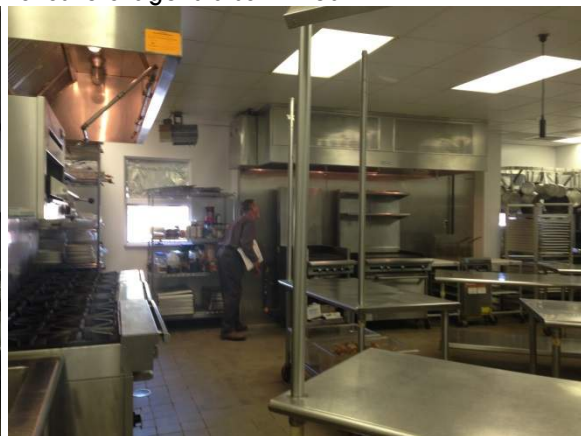
The instructional kitchens are cramped and seem undersized. The acoustics are poor in most areas, due to the loudness of the mechanical equipment, even before the cooking hoods are turned on. The layout makes it difficult for students to see the instructor. The exterior windows are small, and access to natural light is limited. The upper panels of the exterior windows have been covered with aluminum cooking foil, in an effort to cut some of the glare. There is inadequate space for the students to photograph their work for their portfolios. Storage is also limited.

View of Garde-Manger Kitchen

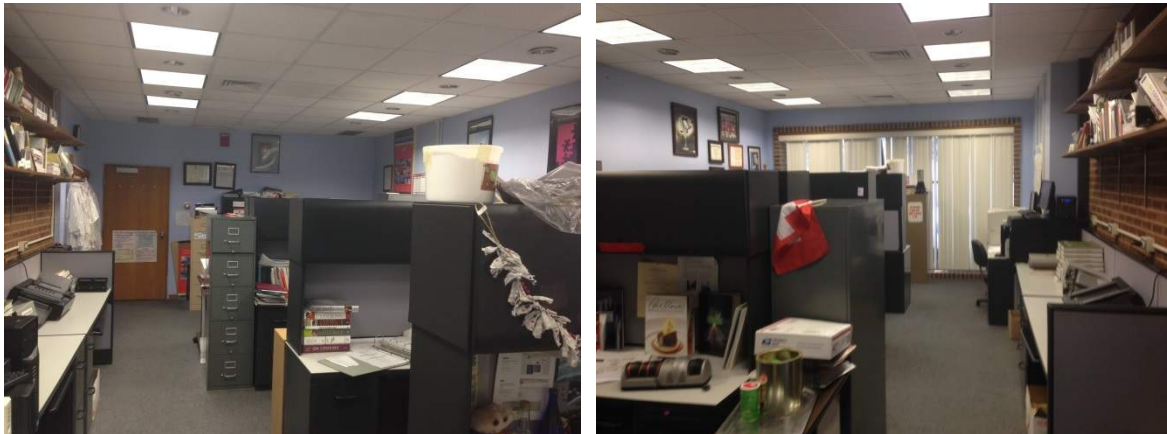
1. Ceilings:
There are acoustic tile ceilings throughout these areas, and they appear to be in fair to good condition. Some tiles are discolored or damaged and should be replaced.
2. Partitions/Walls:
The interior walls in these areas are painted CMU or drywall.
3. Floors:
The existing carpet is in fair to good condition.
4. Other Items:
The faculty/staff offices appear to be adequate for the current number of employees. However, if the Admissions staff is moved to the Main Building, additional offices will be needed. The Faculty also expressed a desire to have a desk/alcove immediately off each classroom.

Two Views of Shared Office at North Side of Building

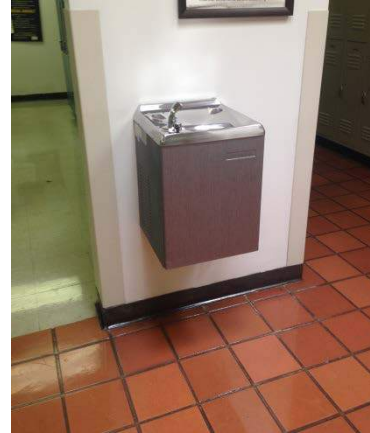
Water Fountain

There are no ADA-compliant lockers or benches in the locker room. The water fountain is not ADA-compliant. The restrooms located directly off the locker room are not ADA-compliant.

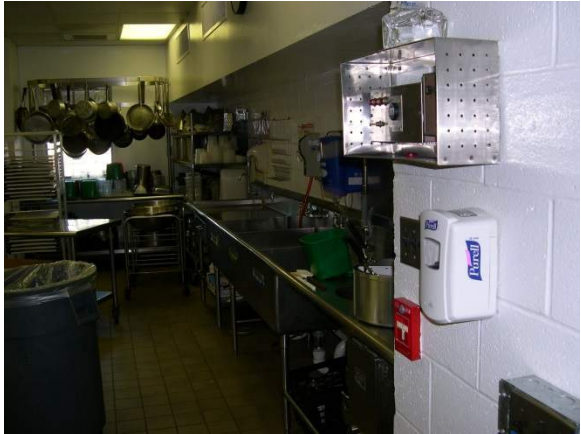
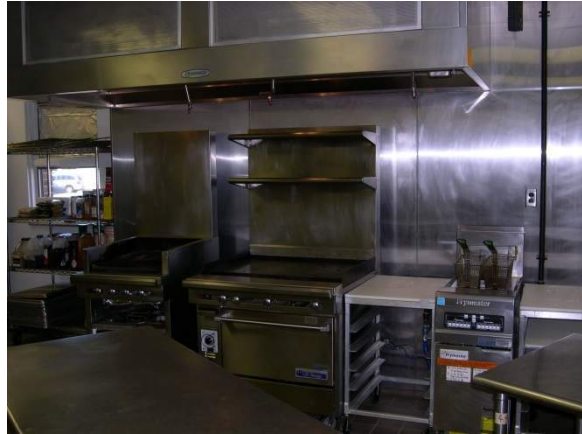
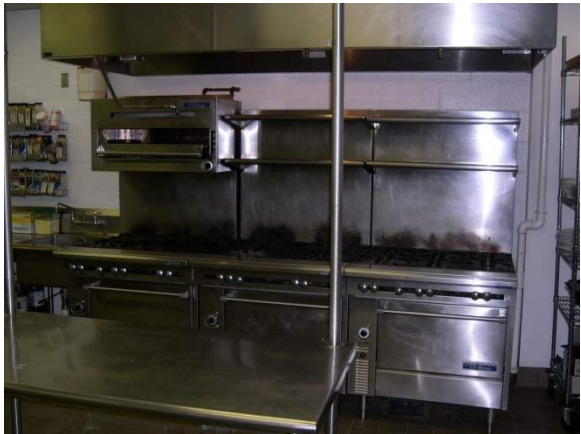
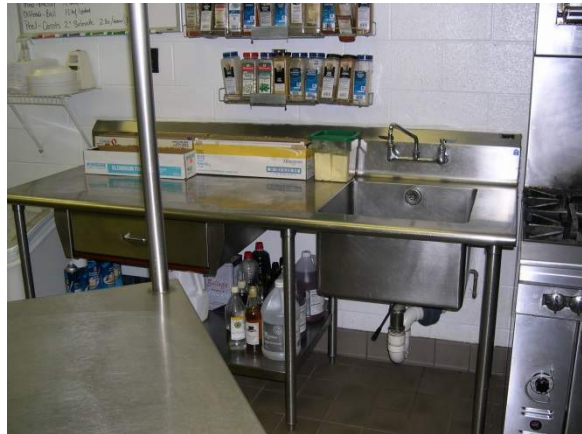
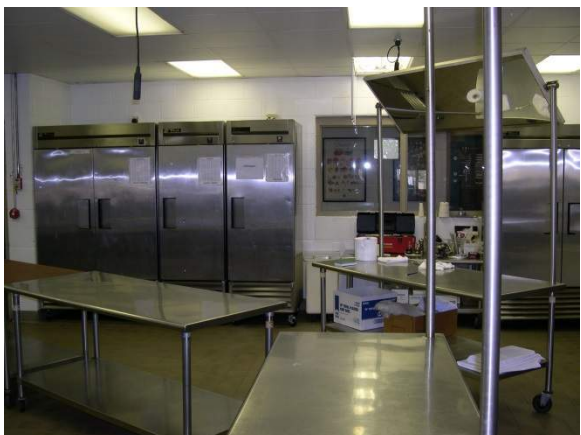
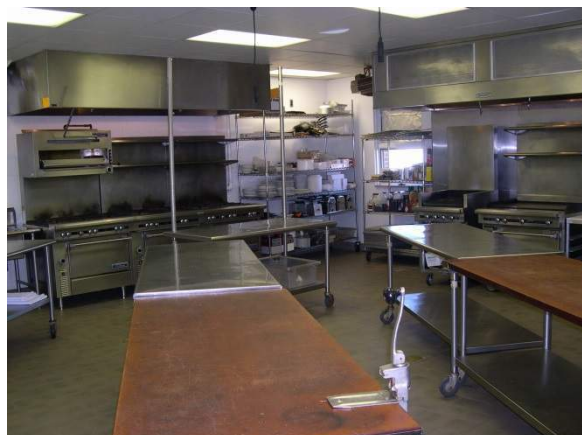
Views of the Existing Garde-Manger / Skills Kitchen:

<u>Equipment</u>	<u>Age</u>	<u>Comments</u>
Refrigerator (2-Door)	10 Yrs.	
Refrigerator (Single Door)	5 Yrs.	
Freezer (Single Door)	5 Yrs.	
Work Table (7)	24 Yrs.	Possibly reuse, replace 1 mirror.
Refrigerator (2-Door)	5 Yrs.	
Work Table with Sink	24 Yrs.	Possibly reuse, replace trim.
Ventilator (Hood)	24 Yrs.	Non-Code Compliant - Replace.
Fire Suppression System (2) & 24 Yrs.	3 Yrs.	Non-Code Compliant - Replace
Range (6-Burner) (3)	5 Yrs.	
Shelving Units (3)	12 Yrs.	
Ventilator (Hood)	3 Yrs.	
Char-Broiler (24" wide)	3 Yrs.	
Griddle Top Range	3 Yrs.	
Floor Fryer	3 Yrs.	
Hand Sink	24 Yrs.	Replace trim - possibly reuse.
Three-Bowl Sink	24 Yrs.	Replace trim.
Disposer	24 Yrs.	Replace due to age/corrosion.
Mixing Bowls (4)	24 Yrs.

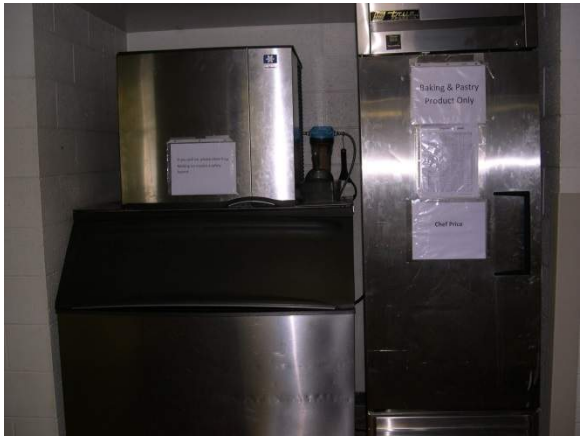
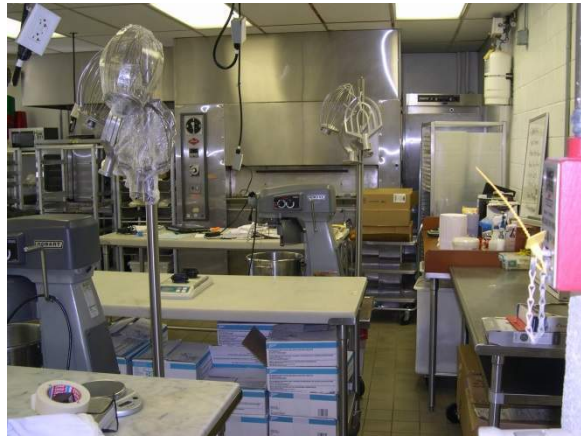
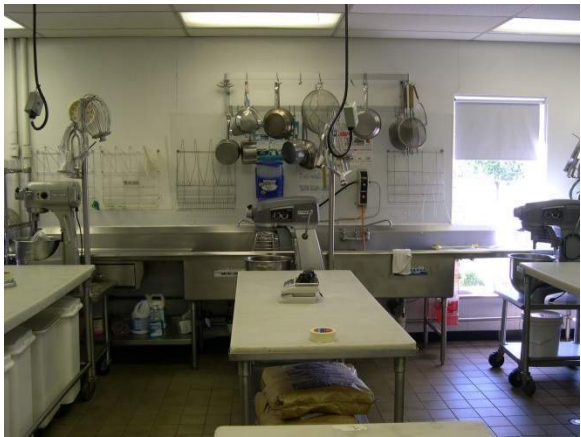
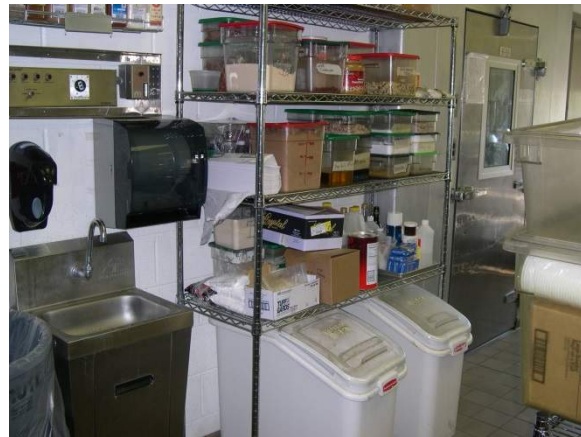
Views of the Existing Bake Shop Kitchen:

The Bake Shop Kitchen is located between the Garde-Manger/Skills Kitchen and Hot Preparation Kitchen and is tremendously undersized with respect to the current program needs. The kitchen encompasses approximately 800 square feet, with overflow equipment (storage cabinets, ice maker, and upright freezer) positioned in the corridor. Additional work stations/equipment are necessary to enable proper demonstration/training, complete with adequate aisles.

Mixer (20-quart) (5 Total)	2 @ 5 Yrs.	Replace in ten (10) years.
	2 @ 7 Yrs.	Replace in eight (8) years.
	1 @ 1 Yr.	Replace.
Equipment Stand (5)		Replace trim.
Microwave Oven (Residential)	4 Yrs.	Non-Code Compliant - Replace

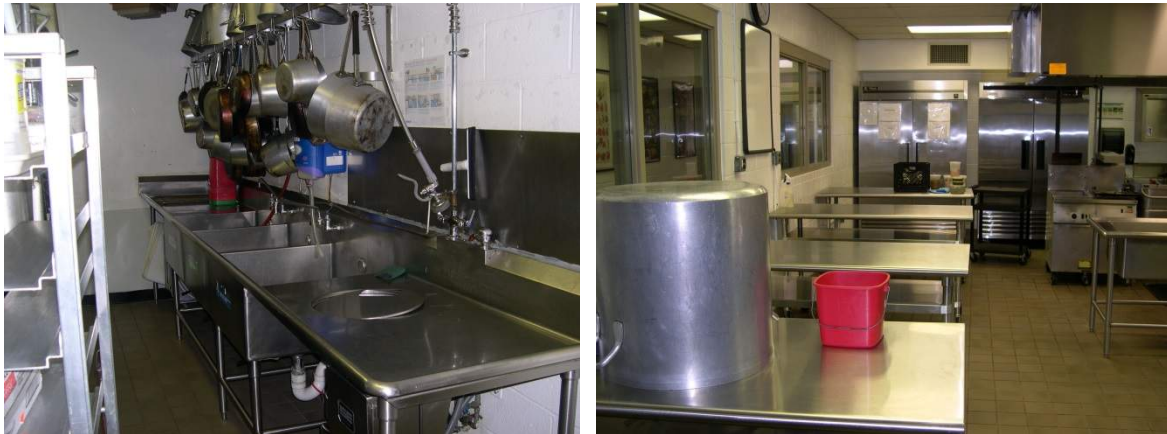
Views of Existing Hot Preparation Kitchen:

The Hot Preparation Kitchen is positioned between the Bake Shop Kitchen and A La Carte Kitchen and is tremendously undersized for the current program needs. An abundance of additional equipment has been installed in this kitchen, rendering limited flow and reduced aisleways. Inadequate work stations are the norm in the 800 square foot kitchen.

The above items are “grandfathered,” excluding corrosion on shelving units. All of the above items must be addressed, if a renovation is undertaken.

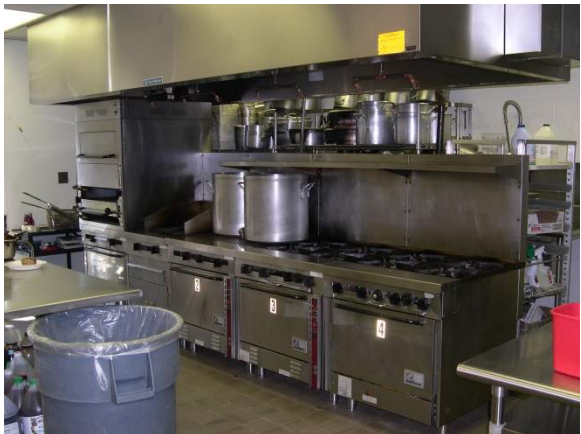
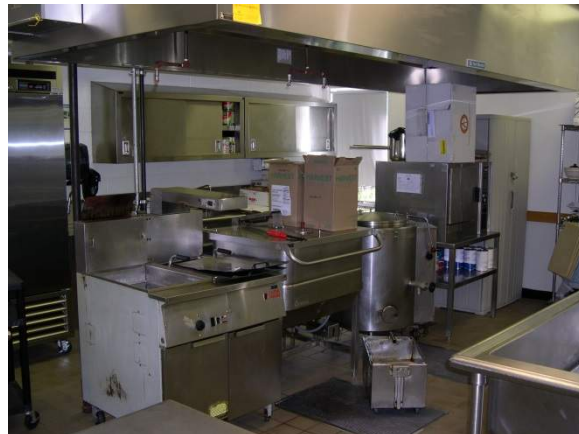
Additional Views of Existing Hot Preparation Kitchen:

<u>Equipment</u>	<u>Age</u>	<u>Comments</u>
Refrigerator (Single Section)	10 Yrs.	Replace in two (2) years.
Work Table (8)	24 Yrs.	Possibly reuse.
Freezer (2-Section)	5 Yrs.	Replace in seven (7) years.
Refrigerator (2-Section) (Saturn)	1 Yr.	Replacement within in next five (5) years is anticipated, due to original quality of unit.
Hand Sink	24 Yrs.	Replace trim.
Work Table with Sink	24 Yrs.	Possibly reuse - replace trim.
Wall Cabinet	24 Yrs.	Possibly reuse.
Utility Cabinet (Rubbermaid)	3 Yrs.	
Ingredient Bin (2)	24 Yrs.	Replace in two (2) years.
Fryer	24 Yrs.	Replace in two (2) years.
Braising Pan (30-gallon)	24 Yrs.	Replace in two (2) years.
Kettle (20-gallon)	24 Yrs.	Replace in two (2) years.
Counter Top Steamer	24 Yrs.	Replace in two (2) years.
Ventilator (2) (Hood)	24 Yrs.	Non-Code Compliant - Replace
Fire Suppression System (2)	24 Yrs.	Non-Code Compliant - Replace
Bain Marie Table	24 Yrs.	Possibly reuse - replace trim.

Range with Oven (2) (4-Burner)	24 Yrs.	Replace in four (4) years.
Range with Oven (Even-Heat Top)	24 Yrs.	Replace in four (4) years.
Char-Broiler	24 Yrs.	Replace in four (4) years.
Upright Broiler	24 Yrs.	Replace in four (4) years.
Mixing Bowl	24 Yrs.	Replace in four (4) years.
Undercounter Hot Cabinet	12 Yrs.	Replace in six (6) years.
Undercounter Smoker	12 Yrs.	Replace in six (6) years.
Shelving (1 Lot)	Varies	Replace four (4) units due to corrosion.
Three-Bowl Sink	24 Yrs.	Possibly reuse - replace trim.
Disposer	24 Yrs.	Replace due to age/condition.

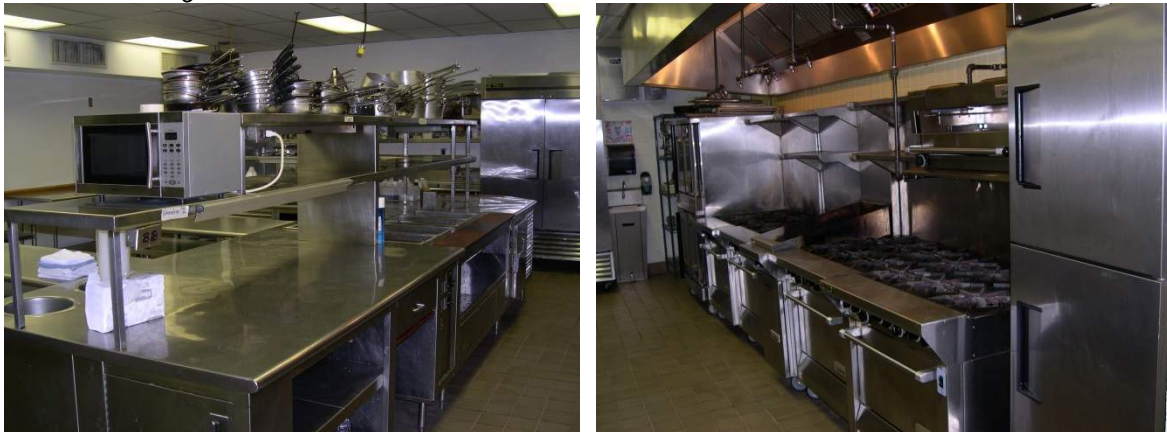
Views of Existing A La Carte Kitchen:

The A La Carte Kitchen, encompassing approximately 925 square feet, adjacent to the dining area and provides a restaurant-type operation for educational purposes. The current program requirements entail the added storage and preparation functions in this room, thereby, rendering the size/design inadequate at best. Note this kitchen also includes a dishwashing area/equipment to support the dining room, as well as a small wait staff service area.

The above items are “grandfathered,” excluding the repositioning of the cooking equipment. All of the above items must be addressed, if a renovation is undertaken.

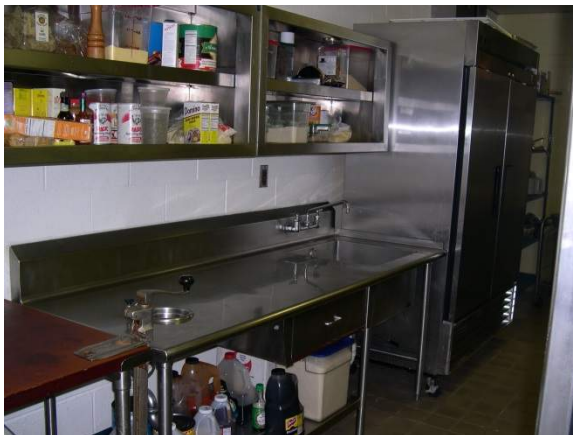
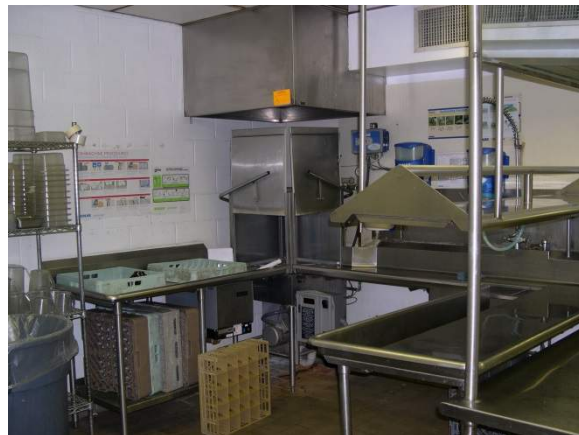
Additional Views of Existing A La Carte Kitchen

<u>Equipment</u>	<u>Age</u>	<u>Comments</u>
Convection Oven (Double Deck)	1 Yr.	
Range with Oven (4-Burner)	1 Yr.	
Range with Oven (3) (6-Burner)	1 Yr.	One (1) Unit with Salamander Broiler.
Char-Broiler	1 Yr.	
Ventilator	24 Yrs.	Non-Code Compliant - Replace
Fire Suppression System	24 Yrs.	Non-Code Compliant - Replace
Mixing Bowl	24 Yrs.	Replace in two (2) years.
Shelving (3)	24 Yrs.	Replace in two (2) years.
Refrigerator (2-Section)	10 Yrs.	Replace in four (4) years.
Work Table with Sink	24 Yrs.	Possibly reuse - replace trim.
Work Table (6)	6 Yrs.	Possibly reuse.
	& 24 Yrs.	
Refrigerator (Single Section)	2 Yrs.	
Chef's Counter	24 Yrs.	Possibly reuse, replace components.
Dishwasher	24 Yrs.	Replace due to age.
Soiled Dish Table	24 Yrs.	Possibly reuse, replace trim.
Disposer	24 Yrs.	Replace due to age.
Clean Dish Table	24 Yrs.	Possibly reuse.
Condensate Hood	24 Yrs.	Possibly reuse.
Three-Bowl Sink	24 Yrs.	Possibly reuse, replace trim.

Waitress Counter	24 Yrs.	Possibly reuse.
Ice / Water Station	24 Yrs.	
Coffee Maker	10 Yrs.	By Vendor
